# SIMULATED REENTRY HEATING BY TORCHING

Gale A. Harvey  
NASA Langley Research Center

## ABSTRACT

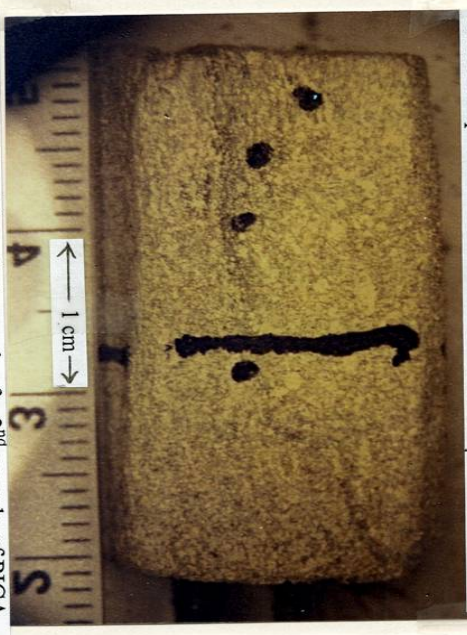
Figure 2. Pre-torching photograph of a 2<sup>nd</sup> sample of JPL PCA.

A second sample of JPL PICA was torched. Figure 2 is a photograph of the PICA before torching. Figure 3 is a photograph after torching. Four K thermocouples were embedded in this sample, at 0.2 cm, 0.65 cm, 1.0 cm, and 1.9 cm depth. The PICA was placed in Shuttle TPS tile-core collar, and positioned in the propane flame similar to the first sample. The temperature histories are presented in figure 4. This sample of PICA ablated more than 0.2 cm at 20 minutes of heating, exposing the shallowest thermocouple and saturating it. A tongue of denser fiberform (figure 3) was less ablated than surrounding areas and the resulting uneven surface probably caused the similar temperature histories for the 0.65 cm and 1.0 cm depth thermocouples.

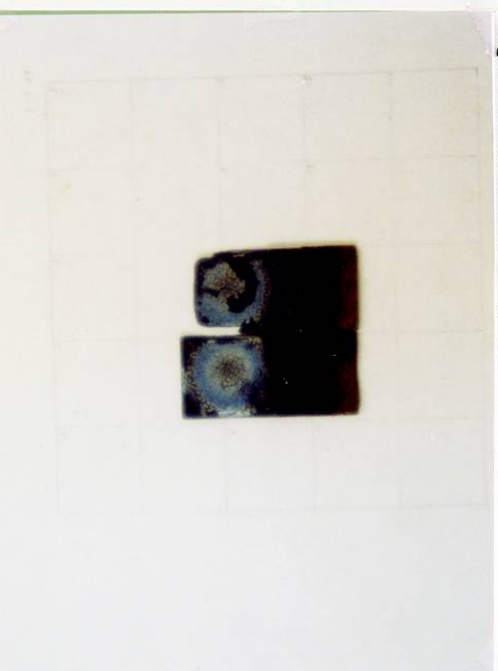
Figure 10. Post-torchings photograph of thin PICA sections.

Thin (~0.40 cm) samples of light and dark MSL PICA were torched to further investigate color variations. Two K-thermocouples were placed on the back side of each thin section (figure 9). A 2.5 cm wide glass slide was used to clamp the thermocouples to the PICA. The PICA samples with glass slides were held in forceps and positioned in a propane torch flame for 5 minutes. A photograph of the torched thin PICA samples is presented in figure 10. The temperature histories are presented in figure 11. One thin PICA sample was inadvertently torched on the glass cover (which broke) for a few seconds. One of the thermocouples came open during the testing and the temperature on the hottest area of the back side is not available. The torched (front side) of the two thin samples are similar in appearance, but there was significant erosion (ablation) of the fiberform on the back of the sample which had the broken glass cover slide. There is a fine, white fiber ash on the torched surface of each of these samples.

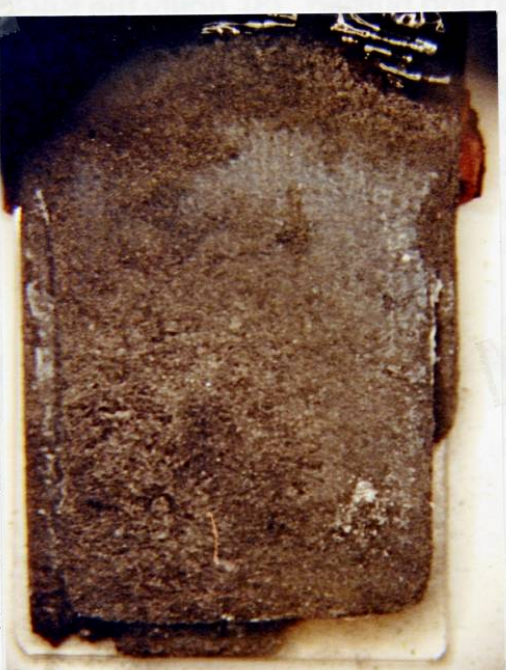
Figure 12. Enlarged photograph showing edge effects of torching.

Four of the five thin samples of torched PICA appear to be layered (or undercut by the torching). That is, the ablation around the edges is not uniform. This apparent layering does not correlate with color, which was relatively uniform for each sample (but varied from sample to sample).

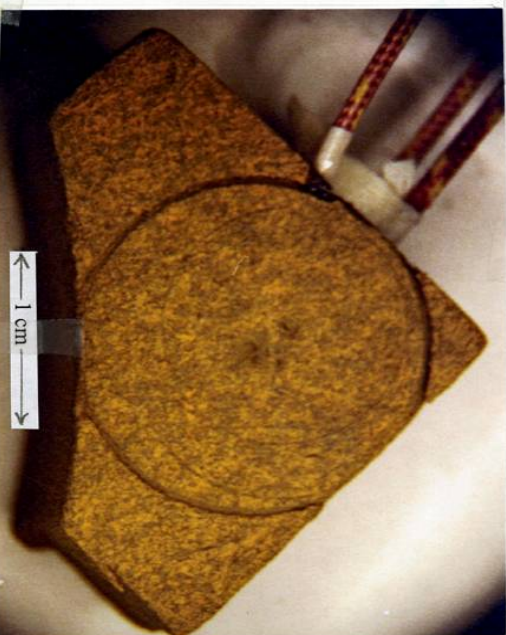
Figure 17. Pre-torch photograph of small 1-inch PtCA sample.

The edge effects seen in the thin samples was not well understood, so torching of larger and thicker samples was performed. A small (~ 2.5 cm across, figure 17) sample, and a larger (~5 cm across, figure 18) sample by 2.2 cm thick of MSL PICA were prepared for torching. Three thermocouples were embedded horizontally at 0.2 cm, 0.65 cm, and 1.0 cm depth in the smaller sample. The thermocouples were potted at side entrance ports with a small amount of 5 minute epoxy. Four K thermocouples were embedded at 0.2 cm, 0.65 cm, 1.0 cm, and 1.9 cm depth in the larger PICA sample. The PICA samples were held in forceps and positioned in a propane torch flame for about 20 minutes (figures 19 and 20). The propane valve was adjusted to have the tip of the inner blue flame 4.4 cm from the torch nozzle. The propane flow was slightly increased periodically during the torching to maintain the inner blue flame at 4.4 cm as the pressure inside the propane bottle decreased slightly due to evaporation of the propane. The small (2.5 cm) sample of PICA was torched for five minutes a second time (figure 21). The small and large 2.2 cm thick samples were subsequently torched for about 10 minutes (figures 22 and 23). The flame diameter was about 0.5 cm and the brightest (hottest) surface char area was about 1.5 cm in diameter. The 0.5 centimeter diameter faint blue flame spreads into a thin (~ 1mm thick sheet of about 5 cm diameter) at the surface of the PICA. The hot center of the propane flame is reduced in oxygen due to nearly complete burning of the propane, but the lower temperature outer regions of the flame are mixed with air. These outer regions are the regions of greatest ablation of the fiberform. The same data logger was used for both the small and large PICA samples; different terminal blocks and thermocouples were used for the two PICA samples.

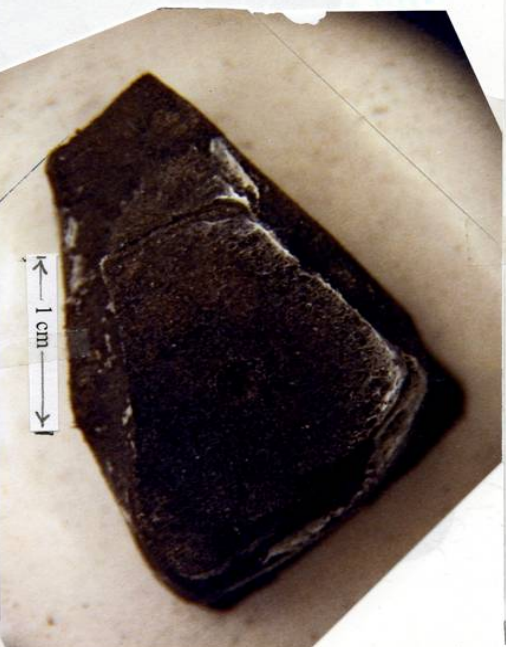
Figure 19. Post-torch photograph of small 1-inch PtCA sample.

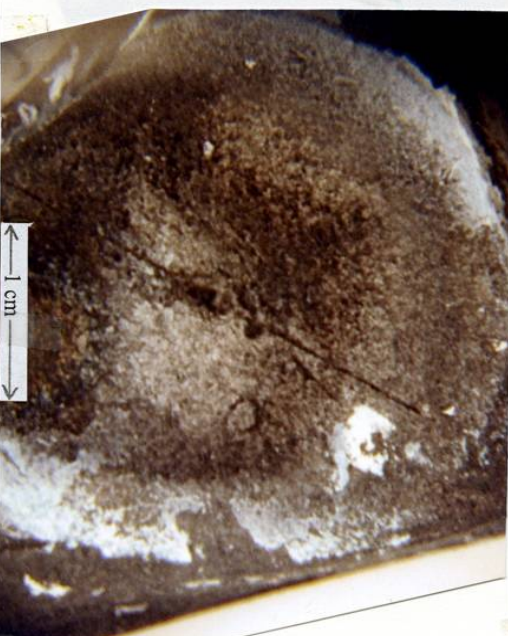
Figure 20. Post-torch photograph of large 1-inch PtCA sample.
